FPDP-RPT-0047

**Final Sewer Inflow and Infiltration Study and Report  
at the Paducah Gaseous Diffusion Plant,  
Paducah, Kentucky**

Date Issued—October 2016

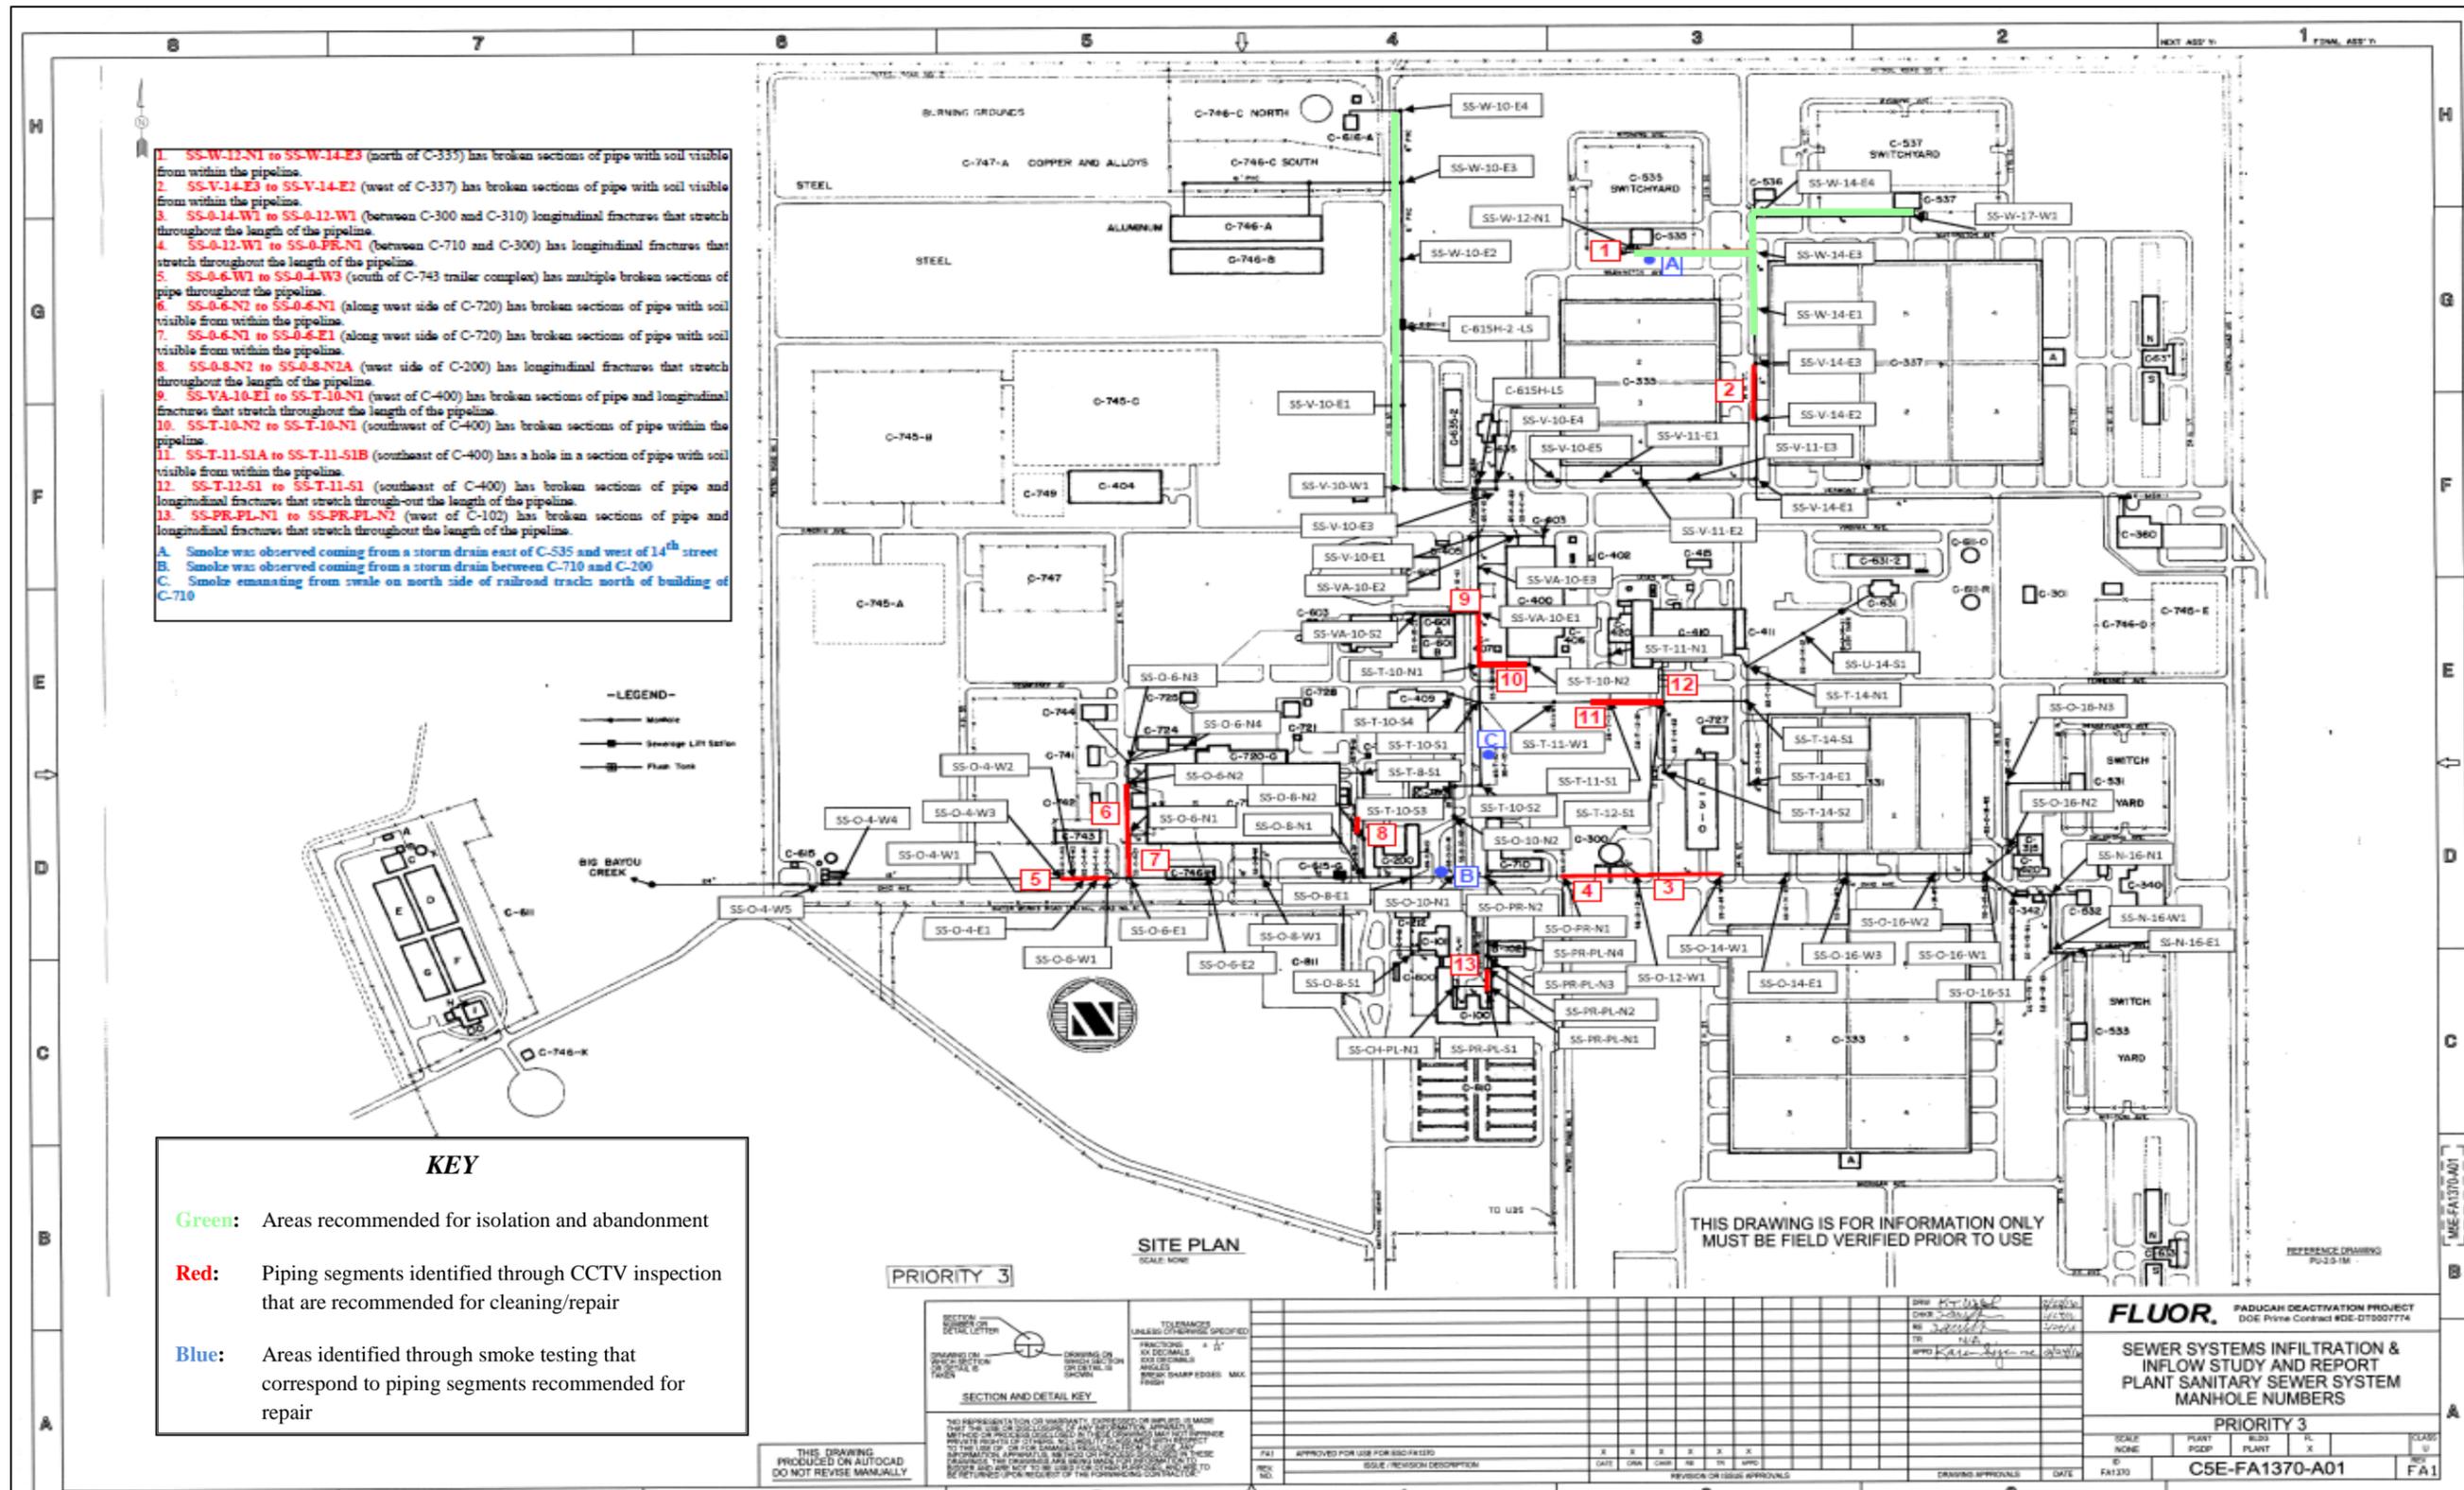
Figure 1. Drawing C5E-FA1370-A01 Revision FA1

Figure 1 indicates areas for which isolation/abandonment or cleaning and repair are recommended.

Figure 1 indicates areas for which isolation/abandonment or cleaning and repair are recommended. Areas to be isolated and abandoned include the northwest segment of the sanitary sewer that runs from the north end of the site near C-616 to the southwest corner of the C-635 Cooling Towers, the segment that runs south of C-535, and the segment that is located south of C-537. Isolation and abandonment of these areas is recommended based on the assumption that the C-535 and C-537 switchyards will be shut down in the very near future and that portable toilet facilities can be used in these switch houses and at C-616 and C-757. Additionally, C-400 personnel have been relocated and the building's sanitary sewer line will be

Priority	Corresponding Item on Field Study Map (Figure 1)	Item Description
1	1 and Area A	Segment 1 and Area A will be isolated and abandoned based on the assumption that the C-535 and C-537 switchyards will be shut down; repair of this section and nearby area is not recommended. Included in the isolation and abandonment activities is the area south of C-537 and the northwest segment of the sanitary sewer running from the north end of the site (near C-616) to the southwest corner of the C-635 Cooling Towers.
1	5	SS-0-6-W1 to SS-0-4-W3 (south of C-743 trailer complex) has multiple broken sections of pipe throughout the pipeline.
2	9	SS-VA-10-E1 to SS-T-10-N1 (west of C-400) has broken sections of pipe and longitudinal fractures that stretch throughout the length of the pipeline.
3	3, 4, and Area B	SS-0-14-W1 to SS-0-12-W1 (between C-300 and C-310) has longitudinal fractures that stretch throughout the length of the pipeline. SS-0-12-W1 to SS-0-PR-N1 (between C-710 and C-300) has longitudinal fractures that stretch throughout the length of the pipeline. Area B is slightly downstream of segment 4.

4	13	SS-PR-PL-N1 to SS-PR-PL-N2 (west of C-102 in the C-100 loop) has broken sections of pipe and longitudinal fractures that stretch throughout the length of the pipeline.
5	6 and 7	SS-0-6-N2 to SS-0-6-N1 (west side of C-720) has broken sections of pipe with soil visible from within the pipeline. SS-0-6-N1 to SS-0-6-E1 (along west side of C-720) has broken sections of pipe with soil visible from within the pipeline.
6	11 and 12	SS-T-11-S1A to SS-T-11-S1B (southeast of C-400) has a hole in a section of pipe with soil visible from within the pipeline. SS-T-12-S1 to SS-T-11-S1 (southeast of C-400) has broken sections of pipe and longitudinal fractures that stretch through-out the length of the pipeline.
7	8	SS-0-8-N2 to SS-0-8-N2A (west side of C-200) has longitudinal fractures that stretch throughout the length of the pipeline.
8	Area C	CCTV inspection and smoke testing of this section of pipe (east of C-409, near railroad track) revealed a defective repair patch approximately 61ft from the upstream manhole. Smoke was visible coming from a small hole in the ground at this location.

9	2	SS-V-14-E3 to SS-V-14-E2 (west of C-337) has broken sections of pipe with soil visible from within the pipeline.

isolated under current deactivation scope; therefore, this section of pipe will not require repair or isolation. Isolation and abandonment activities will be performed by FPDP personnel.

Cleaning and repair is recommended for several segments identified as a result of the field study. Areas of sanitary sewer pipeline considered to be main transport paths for sewage were given first priority as catastrophic failures of these sections would result in the greatest impact to the site by causing sitewide outage of the sewage system. Areas servicing buildings with current and anticipated high staffing levels will be cleaned and repaired once the highest priority segments are completed. The recommended segments of pipe to be cleaned and repaired are listed and prioritized in Table 2.
