West Valley Demonstration Project

Doc. ID Number	WVDP-520
Revision Number	5
Revision Date	05/25/2022

**NORTH PLATEAU
PERMEABLE TREATMENT WALL
S-09 STORM WATER DISCHARGE OUTFALL and PARSHALL FLUME
LAGOON 3 EMBANKMENT
OPERATIONS AND MAINTENANCE PLAN**

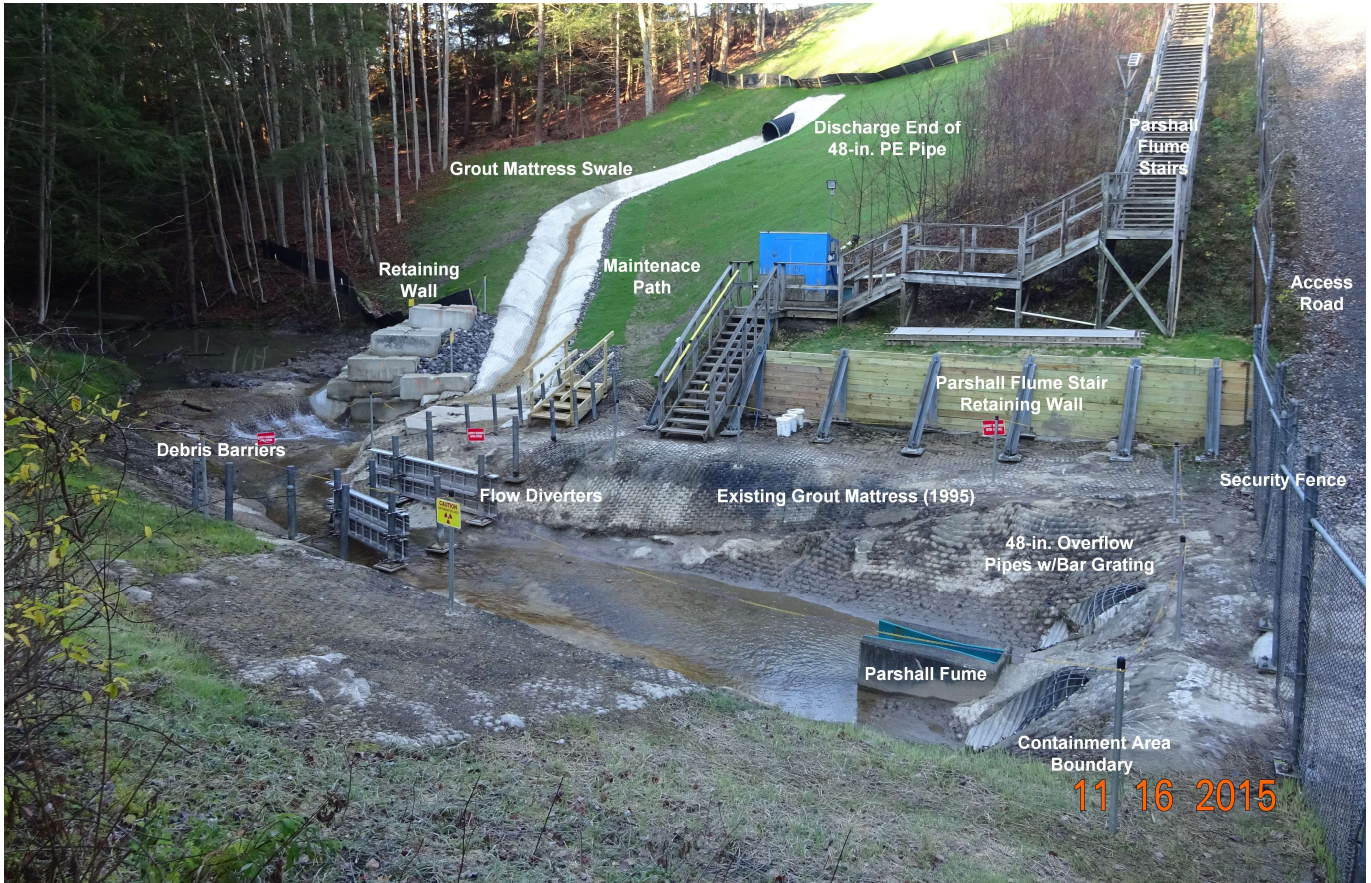
North Plateau Monthly Inspection Report S-09 Storm Water Discharge Outfall & Parshall Flume

Smart-Ditch™ Drainage Swale

What to Look for - Excessive Sediment in invert of Smart-Ditch™, Voids under liner, woodchuck holes

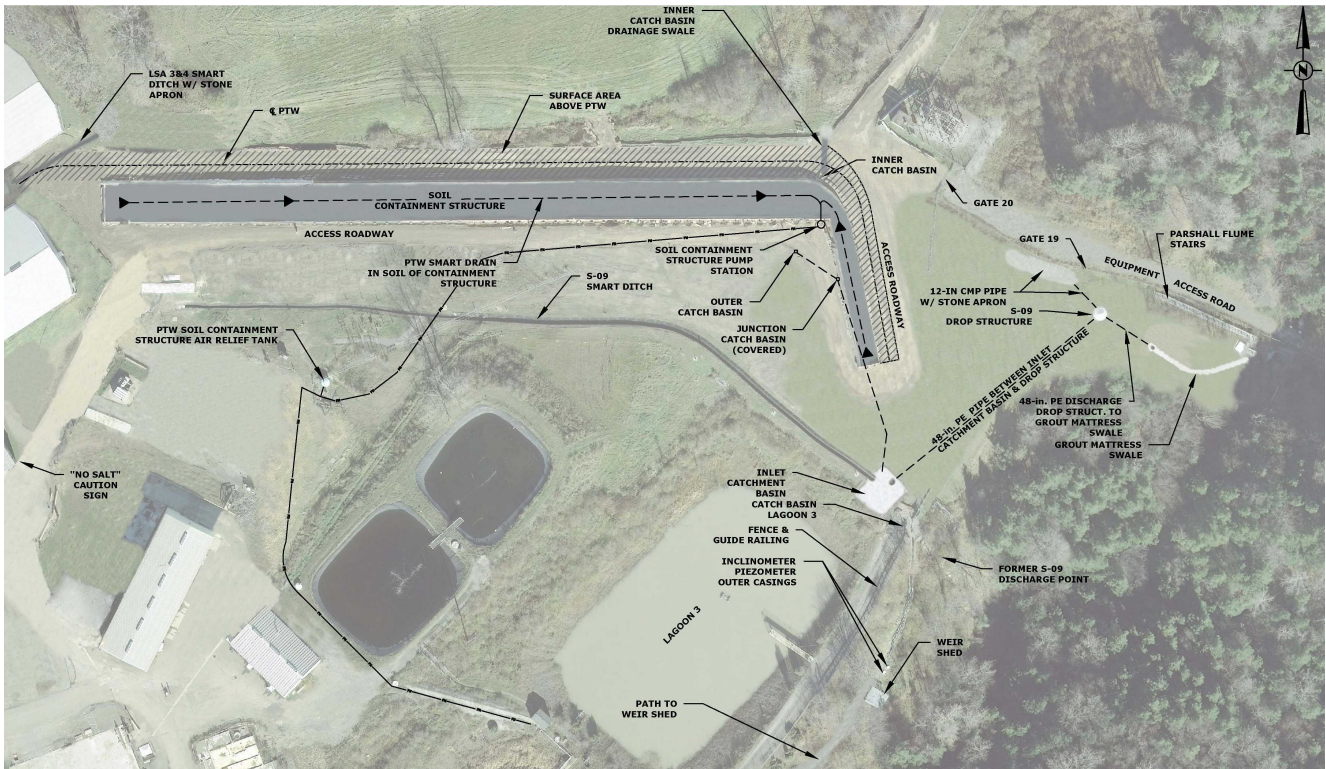
Component Identification & Location Photo

Catch Basin at North East Corner of Lagoon 3

What to Look for - Debris on grating
